HAZARDOUS FPE CIRCUIT BREAKERS AND PANELS

(Updated March 29, 2024)

Information for Homeowners, Inspectors, and Electricians

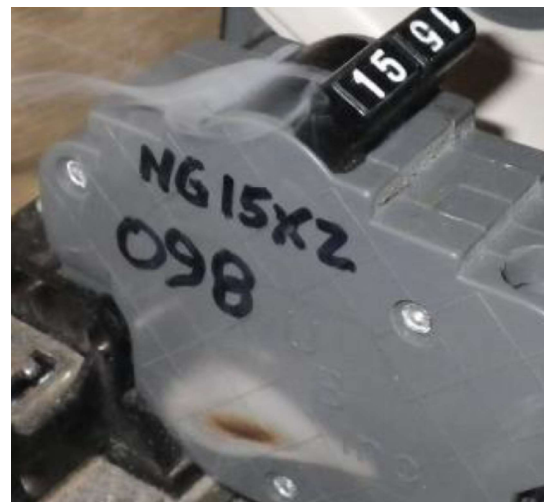
FIGURE 3 - DEFECTIVE UBI 15A BREAKER CONDUCTING 60 AMPS WITHOUT TRIPPING

The UBI (Connecticut Electric) 15-amp double-pole breaker being tested at right is carrying 60 amps without tripping. This brand of breaker is promoted and sold as a "safe" replacement for the FPE breakers.

There is a burn mark developing on the side of the breaker from heating of an internal component, and smoke is coming out of its toggle handle slot.

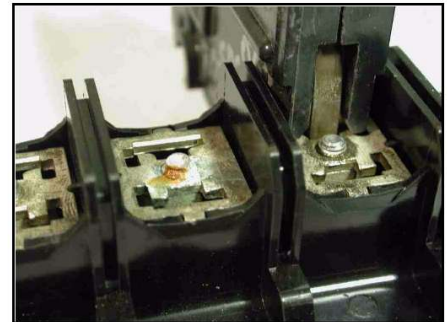
C. Stab socket on a post, attached with 8-32 steel screw.

Of the three types illustrated above, the one shown in Figure 5-C is known to have a high probability of deteriorating and overheating of the stab socket structures when subjected to significant current flow. Each individual stab socket plate is connected to its bussbar via a post (spacer), and the assembly is held together by an 8-32 steel screw. FPE panels with this construction are prone to overheating failure. Eight of the panels of the present study that showed evidence of serious overheating were constructed this way. One example is shown in Figure 6.

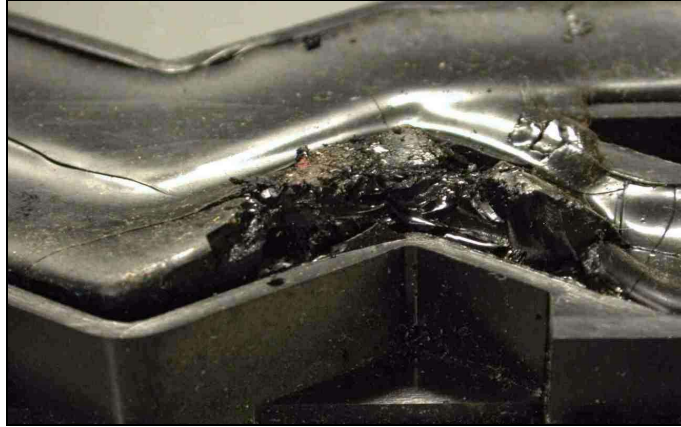
FIGURE 6 - OVERHEATING AT THE CONTACT BETWEEN THE BUSSBAR AND THE STAB SOCKET ASSEMBLY CAUSED THIS DAMAGE TO THE INSULATION. (This view is of the backside of the panel. The damage cannot be seen unless the panel is taken out of the enclosure.)

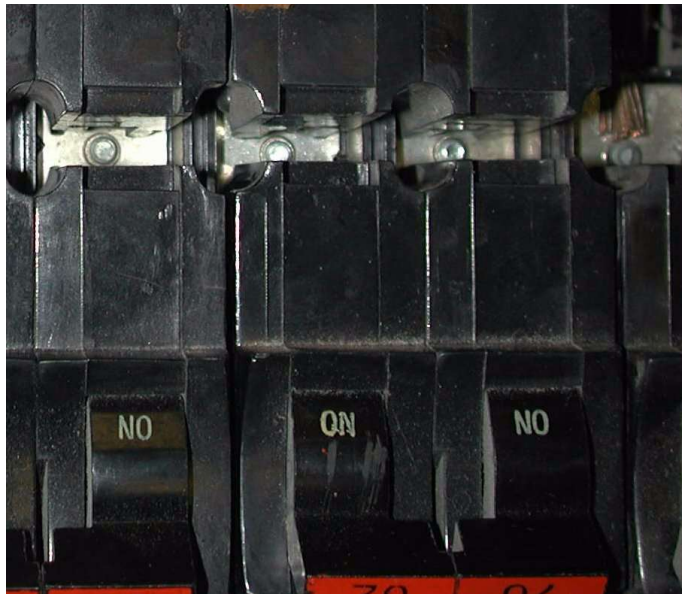
Inspectors can, however, determine if a particular FPE panel has this type of construction, and, to a limited extent, whether it has failing bussbar interconnections that have previously overheated. With the panel cover off, for this type of panel, the inspector can see the ends of the screws that attach the stab socket plates, as shown in Figure 8. (Note: If there are slotted screwheads visible, that is a different type of panel construction.) The stab socket plates and the visible ends of the screws should have a bright metallic look. Darkening, discoloration, or signs of corrosion most likely indicate past episodes of abnormal overheating.

FIGURE 8 - THE ENDS OF THE SCREWS HOLDING THE STAB SOCKET PLATES ARE VISIBLE BETWEEN THE TWO ROWS OF BREAKERS. THIS IDENTIFIES IT AS A PANEL OF THE TYPE SHOWN IN FIGURE 5-C

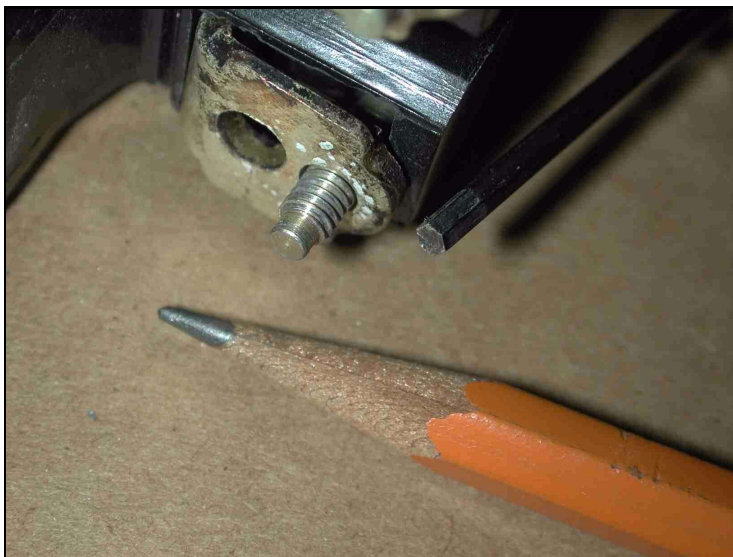
To put the diameter of the 8-32 screw in perspective, it is the same size as used on common receptacles for connecting #14 or #12 copper wire (for 15- and 20-amp circuits), with a diameter of only about 5/32". An FPE panel and main breaker of this type is shown in Figure 9. The main breaker's load output terminal mounting screws and the tiny Allen-wrench that fits them are shown in Figure 10.

FIGURE 10 - ONE LOAD-SIDE CONTACT AND ITS 8-32 CLAMPING SCREW, ON THE FPE 100-AMP MAIN BREAKER OF FIG. 9. THE SCREW-HEAD TAKES A 3/32" ALLEN WRENCH, WHICH IS ONLY SLIGHTLY LARGER THAN THE LEAD OF THE PENCIL. (The larger hole next to the clamping screw provides clearance for the end of the screw that protrudes from the mating contact plate)

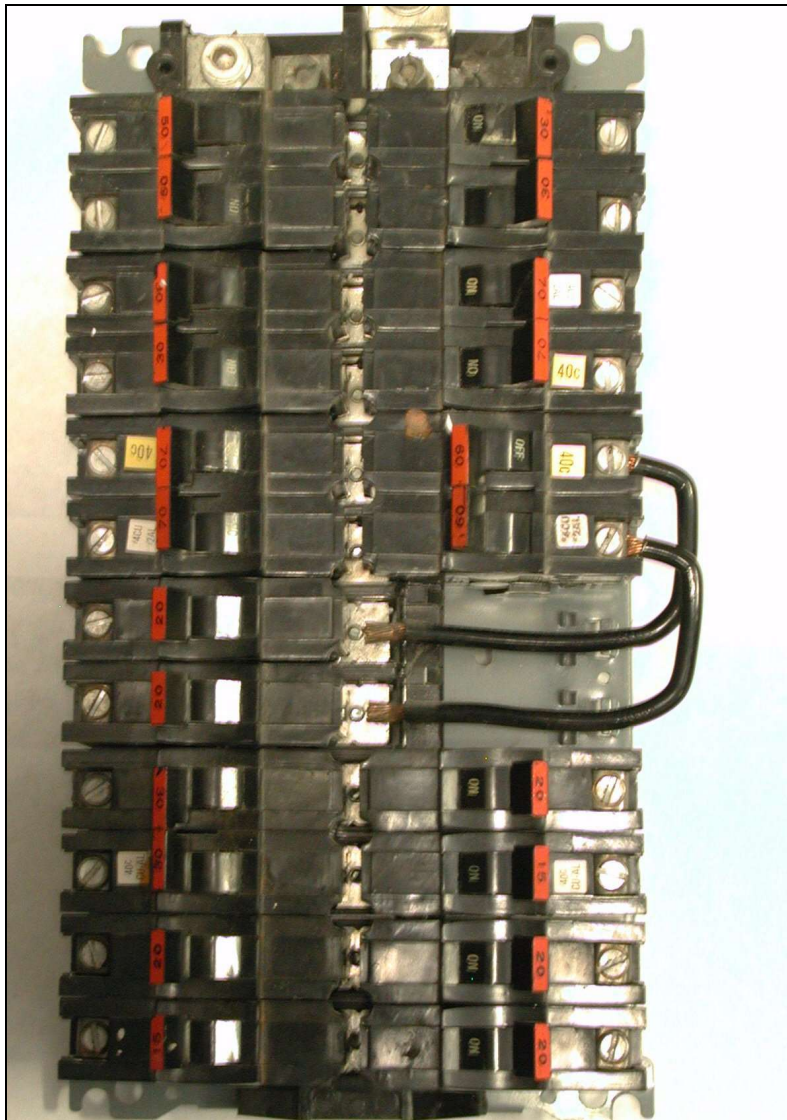
FIGURE 11 - FPE STAB-LOK® "RULE-OF-SIX" (SPLIT-BUS) PANEL WITH NO MAIN BREAKER. THE JUMPER CABLES ON THE RIGHT SIDE FEED THE LOWER SECTION.

On first glance, the FPE Stab-Lok® panel previously shown in Figure 11 looks normal. In fact, however, it clearly demonstrates several of the hazardous failure modes discussed in the previous sections. It is one of those collected for the recent testing. It is from a home built in 1974, whose new owners had determined in 1999 that it should be replaced. Their decision to replace it was in part prompted by information available on the internet regarding FPE breaker problems.⁷ According to the homeowner, who sent it to me for examination and testing, *"We recently had it replaced and found the breaker to the dryer fried in just the way described. Our electrician was astonished. Two others we had bids from dismissed our concerns with contempt."*⁸

Viewing the panel in Fig. 11 from the front, some signs of overheating (as previously discussed) are evident. These are subtle compared to the view looking down at the top right (dryer) breaker, as in Figure 12, below. The main service cable connector has been rotated out of the way for better visibility of the damage. The plastic insulator is burnt and cracked. The breaker's internal mechanism can be seen through the hole burned through its side.

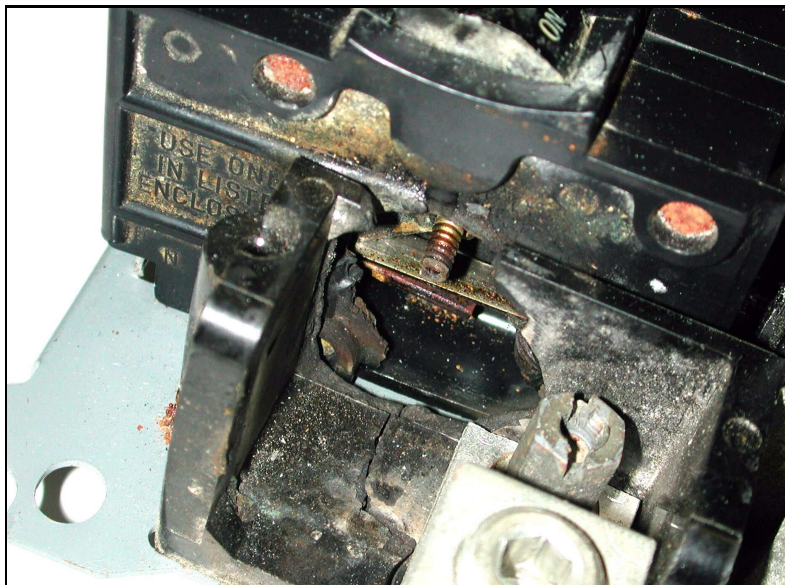
FIGURE 12 - VIEW DOWN TOWARD UPPER RIGHT OF PANEL SHOWN IN FIG. 11. THIS FPE STAB-LOK® TWO-POLE 30-AMP BREAKER FED THE CLOTHES DRYER.

The damage to the breaker, from some previous high-current overload event, is exactly as had been demonstrated in the tests done for the CPSC.^{2,3,4} Those tests demonstrated that, when an FPE breaker jammed and the current exceeded about 300% of the breaker's rating, the side of the breaker disintegrated and/or ignited (smoldered) from the heat being generated within the breaker. This is due to resistive heating of the breaker's internal current-carrying components, mainly the bimetal element and the flexible copper braid that connects to it. This is not an arcing failure, although the damage to the insulating materials of the breaker and panel sets the stage for an arcing fault to occur.

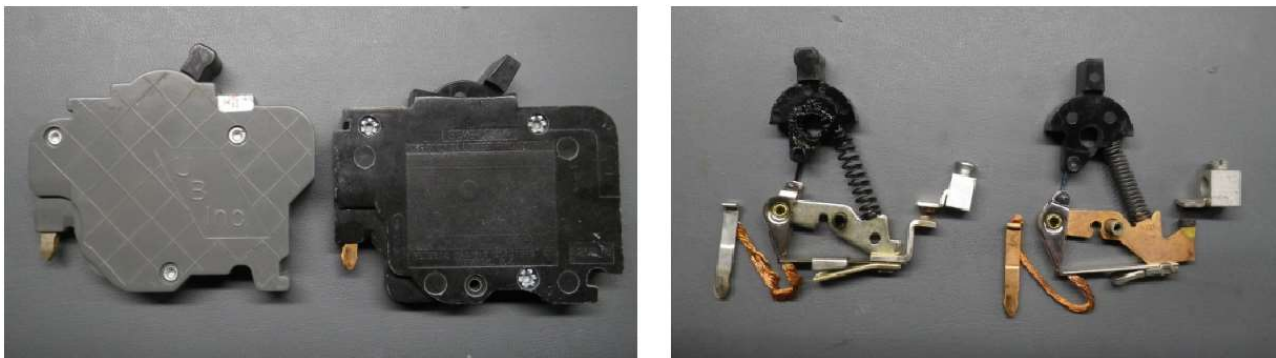
Replacing the FPE breakers with UBI-F breakers is definitely not recommended, as it is likely to result in an increased level of hazard. The UBI-F breakers, marketed by Connecticut Electric Products, are the only new breakers commonly marketed today in the U.S.A. as replacements for the FPE Stab-Lok® breakers. The UBI breaker housings look different, but internally the breakers are essentially the same design as the FPE breakers, as can be seen in Figure 13. The test results for UBI breakers are poor.

FIGURE 13 - UBI-F BREAKER AND FPE BREAKER, OUTSIDE AND INSIDE
(UBI on left, FPE on right in both photos)

Brand new UBI-F breakers have been tested. The results are presented in Section 3.D of this report. The findings demonstrate that the brand new UBI breakers and used UBI breakers from homes (Sections 3.B and 3.C) have a higher failure rate than the FPE breakers that they are intended to replace. Replacing FPE breakers with UBI breakers is a step backward in electrical safety.
