HAZARDOUS FPE CIRCUIT BREAKERS AND PANELS

(Updated March 29, 2024)

Information for Homeowners, Inspectors, and Electricians

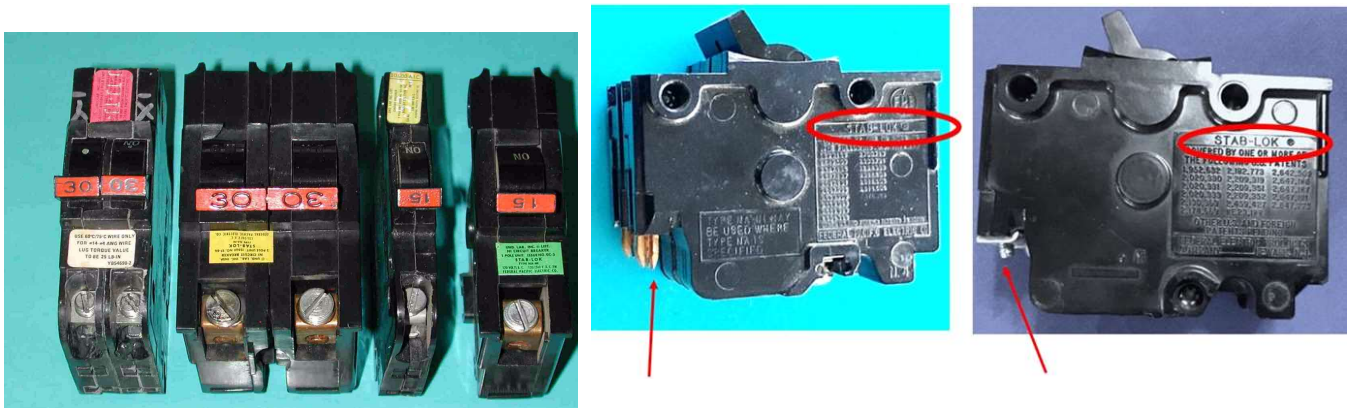
Types NA & NC plug in.

Type NB is “bolted” in.

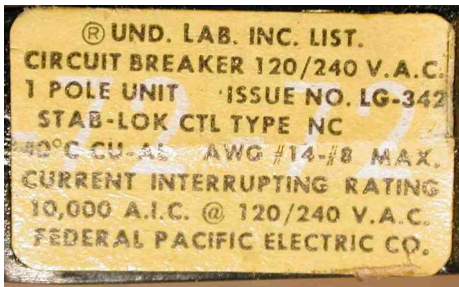
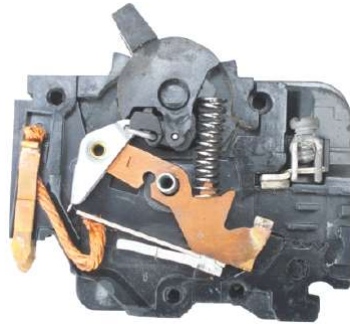
FIGURE 2 - PROCEDURAL PROTECTION vs CIRCUIT PROTECTION

***THE LABEL** and listing provide procedural protection for sellers, installers, and inspectors.*

***THE BREAKER'S** actual performance, - not the label - determines whether it provides proper electrical fire protection for a home.*

Electrical safety for the occupants of a building hinges on the actual performance of the breakers. The labels on the breakers provide no protection in the event of an electrical malfunction. FPE's testing and labeling fraud left building owners and occupants with an increased risk of fire and injury. The defective FPE Stab-Lok® breakers do not meet the functional requirements of the NEC or any other electrical safety code.

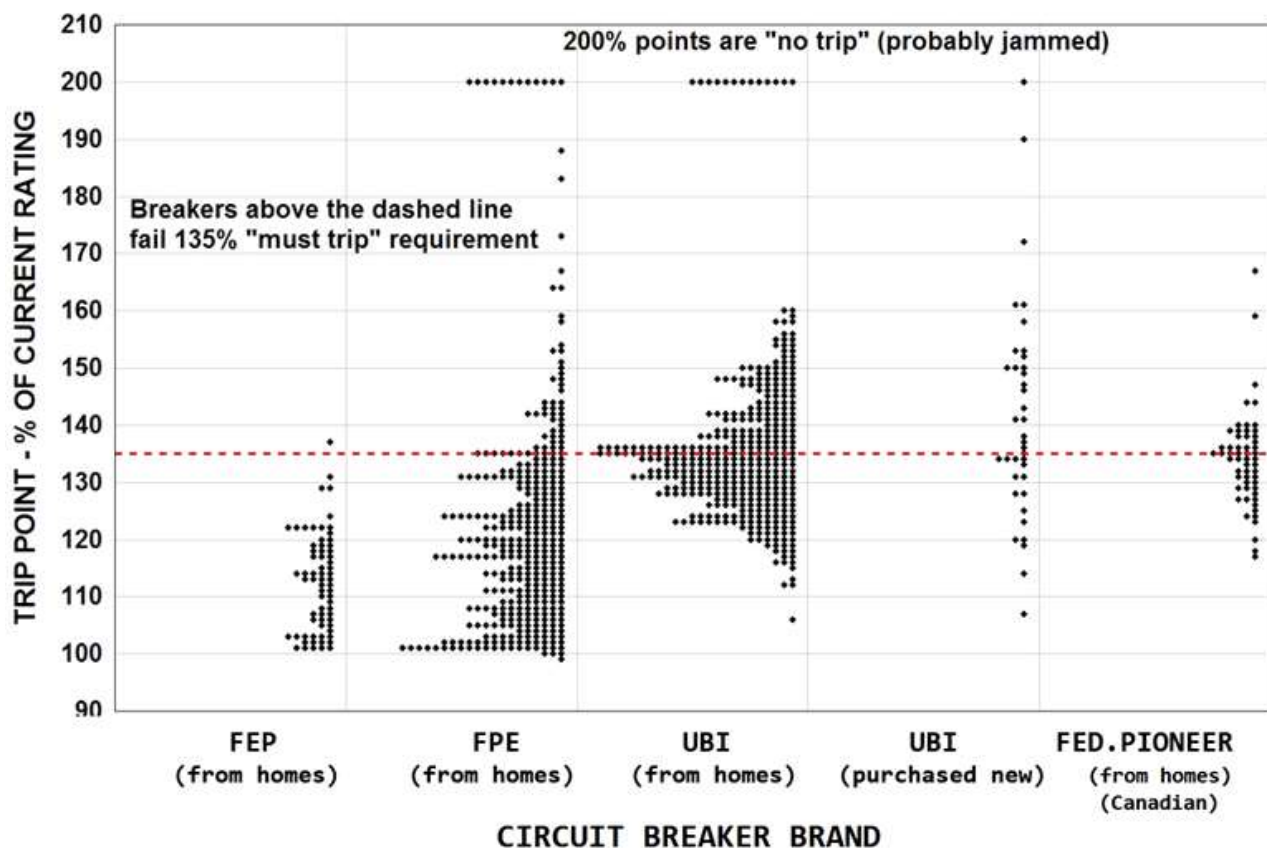
E. Canadian Stab-Lok® Type Brands The last row of Table 3B (p. 11) summarizes the calibration test results for Stab-Lok® type breakers labeled as being manufactured by or for Canadian companies. It shows an overall failure rate of 31% for the breakers tested. They were manufactured for distribution and sale in Canada, and are labeled to indicate CSA (Canadian Standards Association) certification. CSA Certification is equivalent to UL Listing. The calibration test requirement, that breakers must trip at or below 135% of rated current, applies in Canada as in the USA. Brand names for these breakers over the years varied, labeled as Canadian FPE, Pioneer, Pioneer Canada, and, most recently, Federal Pioneer.

Brand new Federal Pioneer Stab-Lok® type breakers are presently manufactured under the ownership of Schneider Electric. The company’s Canadian website (se.com/ca) promotes them with the phrase “Upgrade Your Electrical System with Stab-Lok Federal Pioneer Breaker”. The failure rate for the Federal Pioneer Canadian breakers tested to date (March 2024) is in the same order of magnitude as Stab-Lok® type brands that have been marketed in the USA, as can be seen in the following summary of representative test results.

FIGURE 4 - TRIP CURRENT FOR STAB-LOK® TYPE BREAKERS. (Compiled in 2019.) Each data point is a single pole breaker or one pole of a double-pole breaker. Data includes only breakers that were tested for actual minimum trip current. (Total breakers tested as reported elsewhere in this document also includes breakers tested by go/no-go pass/fail method.)

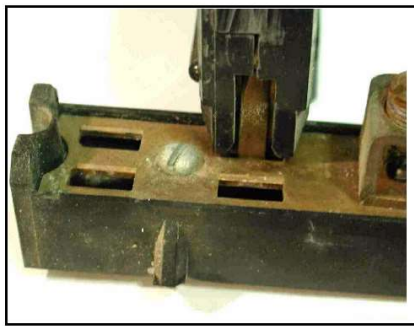
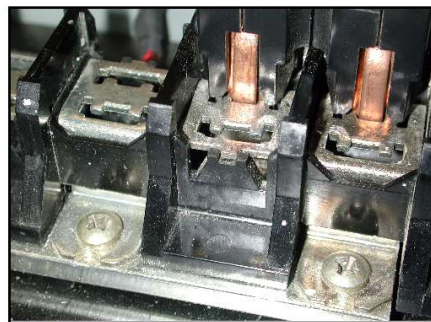
The "panel" is the unit within the enclosure, on which the breakers are mounted. The main electrical service feeders (electrically live, from the meter) are connected at the panel, and the panel has an internal conductor system that distributes the power to the individual circuit breakers. The internal conductor system consists essentially of "bussbars" (thick metal bars) that have sockets incorporated or attached, into which the breakers' "stab" contacts are inserted. There are several different bussbar and Stab-Lok[®] constructions used in FPE panels, three of which are shown in Figure 5.

A. Copper buss bar with punched openings.

B. "Z" clip, clamped to bussbar with 10-32 screw.

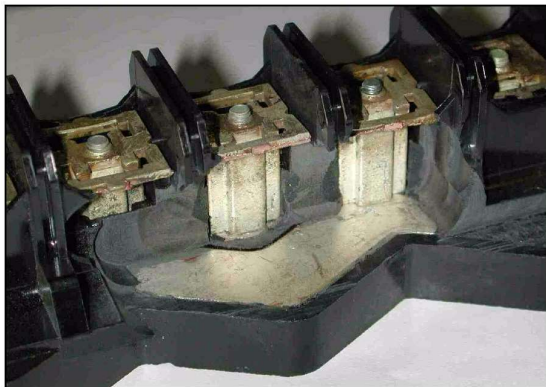
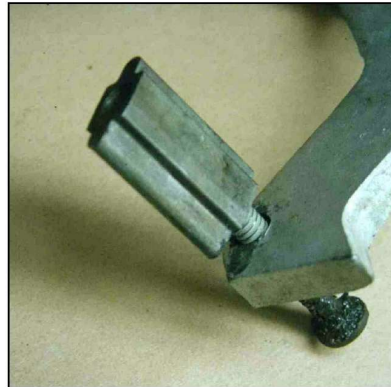
FIGURE 7 - CONDUCTING PATH FROM BUSSBAR TO STAB SOCKET

Of the three types illustrated above, the one shown in Figure 5-C is known to have a high probability of deteriorating and overheating of the stab socket structures when subjected to significant current flow. Each individual stab socket plate is connected to its bussbar via a post (spacer), and the assembly is held together by an 8-32 steel screw. FPE panels with this construction are prone to overheating failure. Eight of the panels of the present study that showed evidence of serious overheating were constructed this way. One example is shown in Figure 6.

A more serious failure of this type has been documented.¹ In that instance, the failure had been severe enough to ignite a smoldering fire on the plastic insulating material. The fundamental weakness in this design is the use of a single, relatively flimsy 8-32 screw to hold a structure together that can feed several breakers with a total "ampacity" (rated circuit capacity) up to about 160 Amps. Figure 7 shows how the stab socket plate and post are attached to the bussbar.

A. Cutaway - Bussbar, Post, and Stab Socket Plate.

B. Bussbar, Screw, and Post

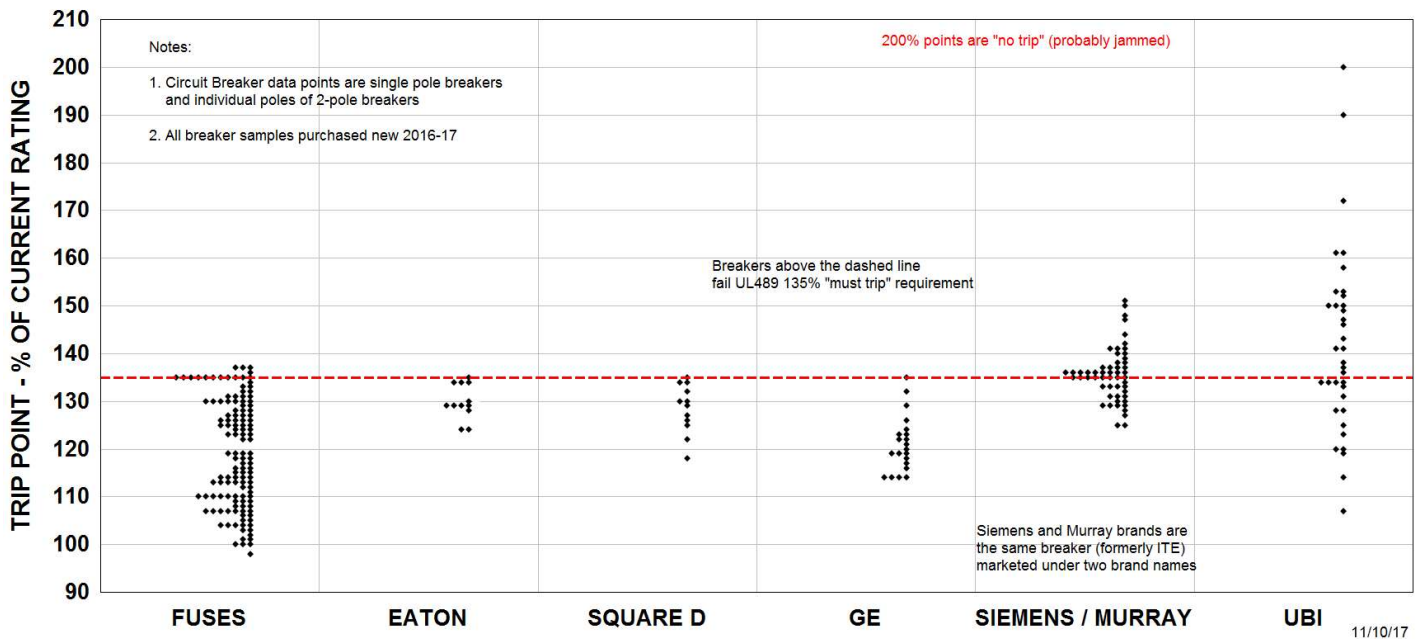
FIGURE 14 - TEST RESULTS: FUSES AND NEW CIRCUIT BREAKERS

There are two options for replacement of the FPE Stab-Lok® panel. If it is not required to increase the service to higher amperage capacity, Eaton makes replacement panel inserts that install in the existing FPE enclosure. If it is necessary to increase the amperage capacity of the service, then a new enclosure and panel must be installed. Eaton, Square D, and General Electric circuit breakers have performed well in tests of new breakers and breakers from homes. Recent test results for brand-new Siemens and Murray (ITE type) breakers show a high failure rate for the 135% trip requirement, and these brands are not recommended. Test results for several brands of circuit breakers, purchased new in 2016 and 2017, are shown in Figure 14.
